# Solent Marine Heritage Assets: Defining, investigating, monitoring and reporting 2008-2011

## HMS *Velox* Wreck Site Report

February  
2011

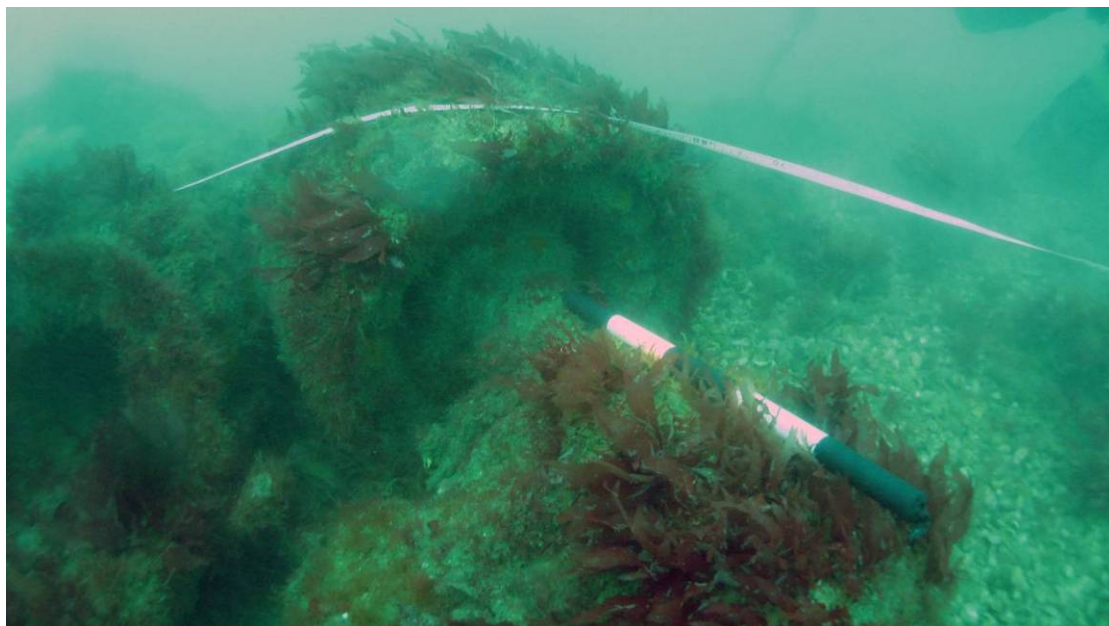
*Figure 7. Engine part visible on seabed.*

The site consisted of a number of individual features separated by areas of seabed. In the central area of the site the diver survey recorded the remains of part of the engine (Figure 7) and a funnel (Figure 8).

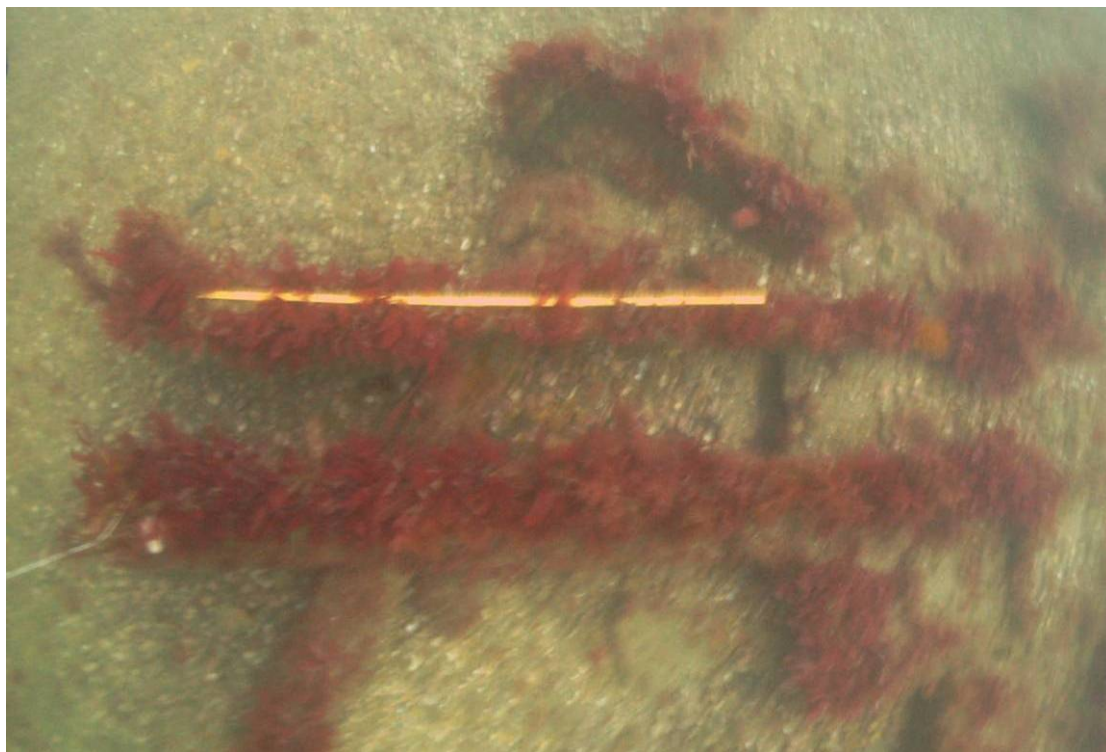
*Figure 9. Shaft visible on seabed.*

Also in evidence on the seabed were the remains of what was presumed to be a portion of the propeller shaft (Figure 9).

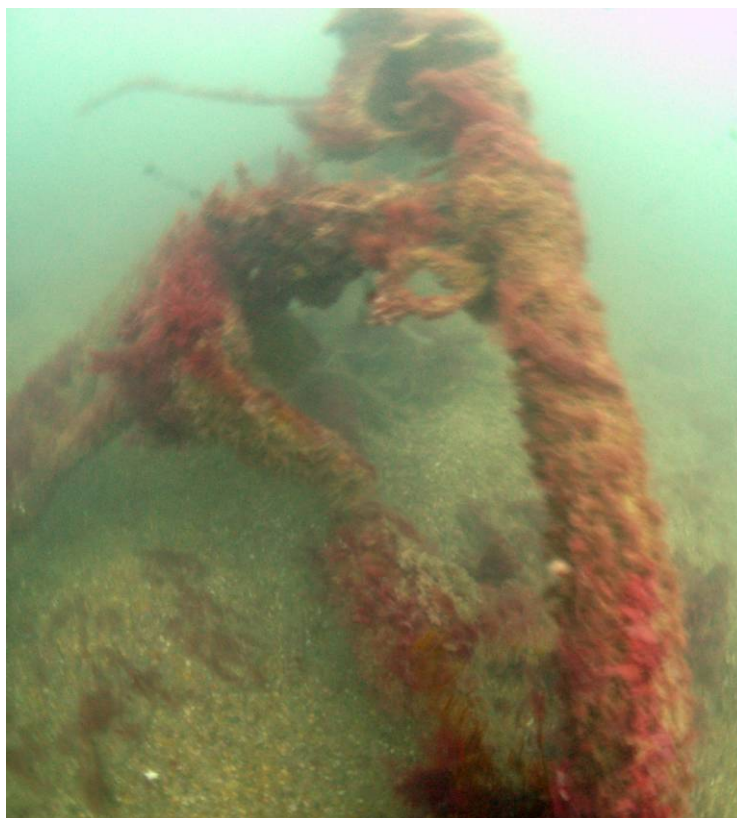
*Figure 10. Upstanding elements of structure.*

To the far east of the site were some upstanding elements, reaching a height of approximately 3 metres (Figure 10). These appeared to be more sections of the shaft seen in Figure 9, presumed part of the propeller array.

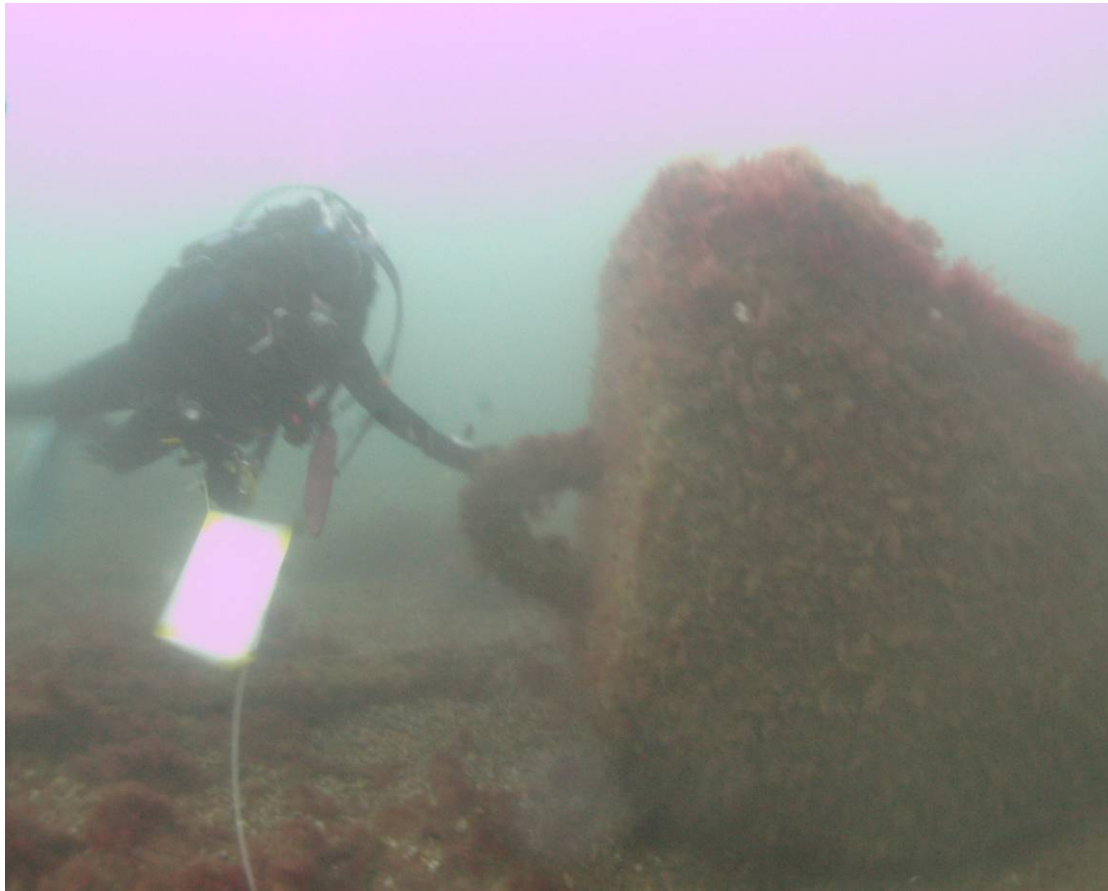
Figure 11. Concrete mooring block.

The site also showed evidence of previous salvage / diver activity, with a series of concrete mooring blocks scattered across the area (Figure 11).
